Combined Visible, LWIR & Corona Inspection

MULTI-SPECTRAL INSPECTIONS

WHY MULTI-SPECTRAL CAMERAS?

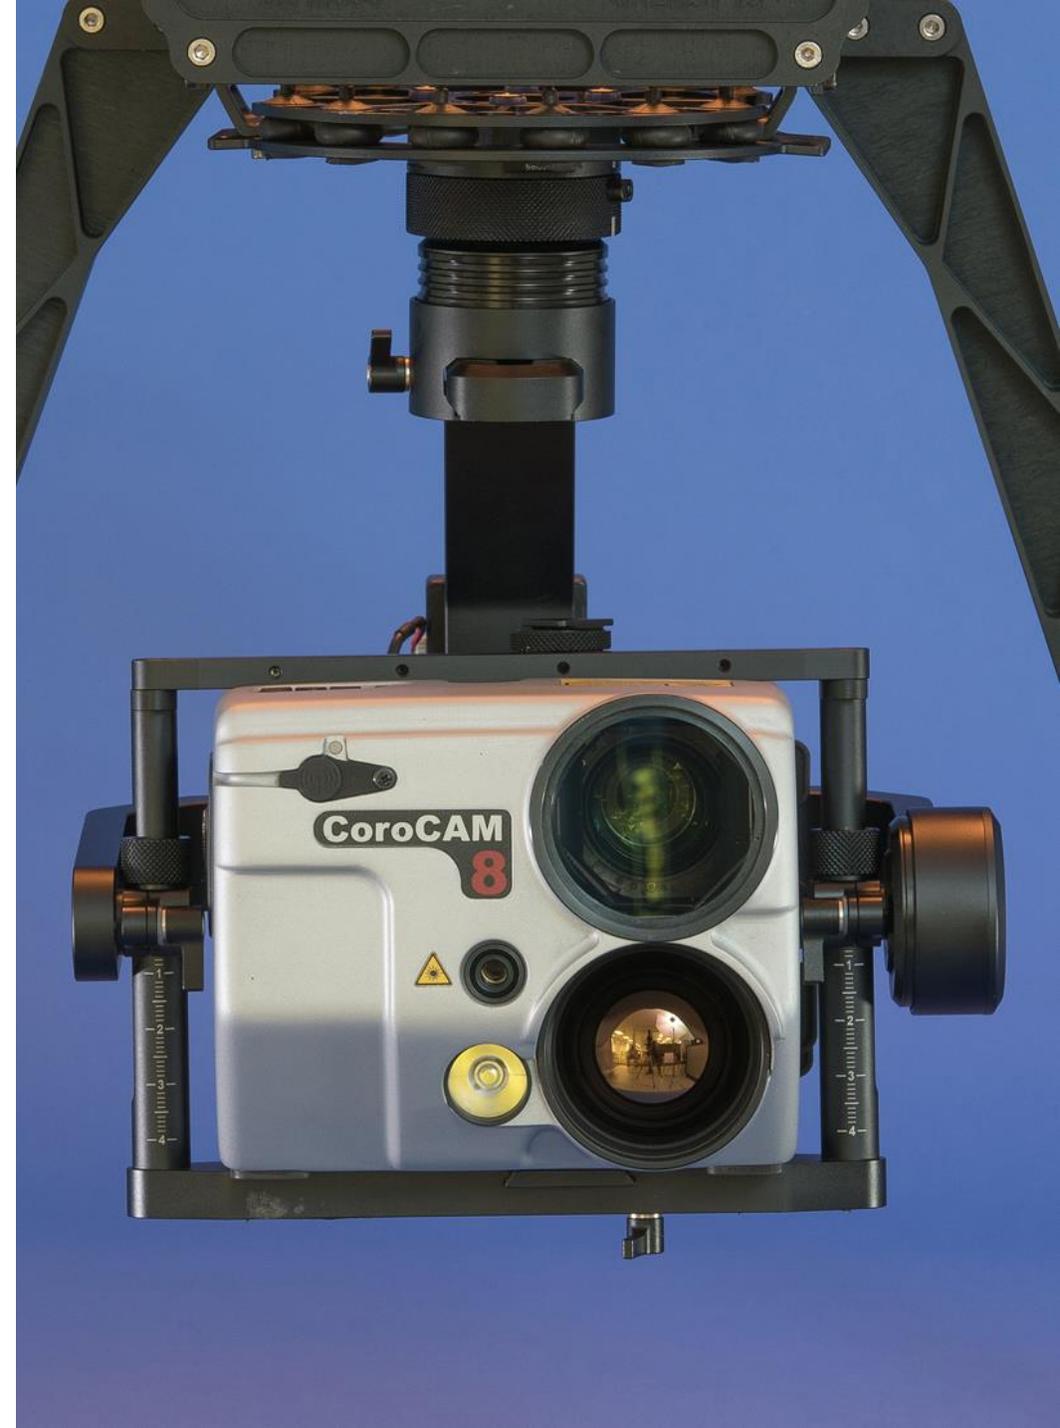
- It made sense to combine the cameras into one tool, making inspections faster and more effective.
- The thermal view with no corona overlay can show hotspots, while a corona discharge will clearly contrast with the thermal view in color and dynamic appearance.
- If corona and a hotspot co-locate then that information can be used to more accurately assess the cause of the fault.

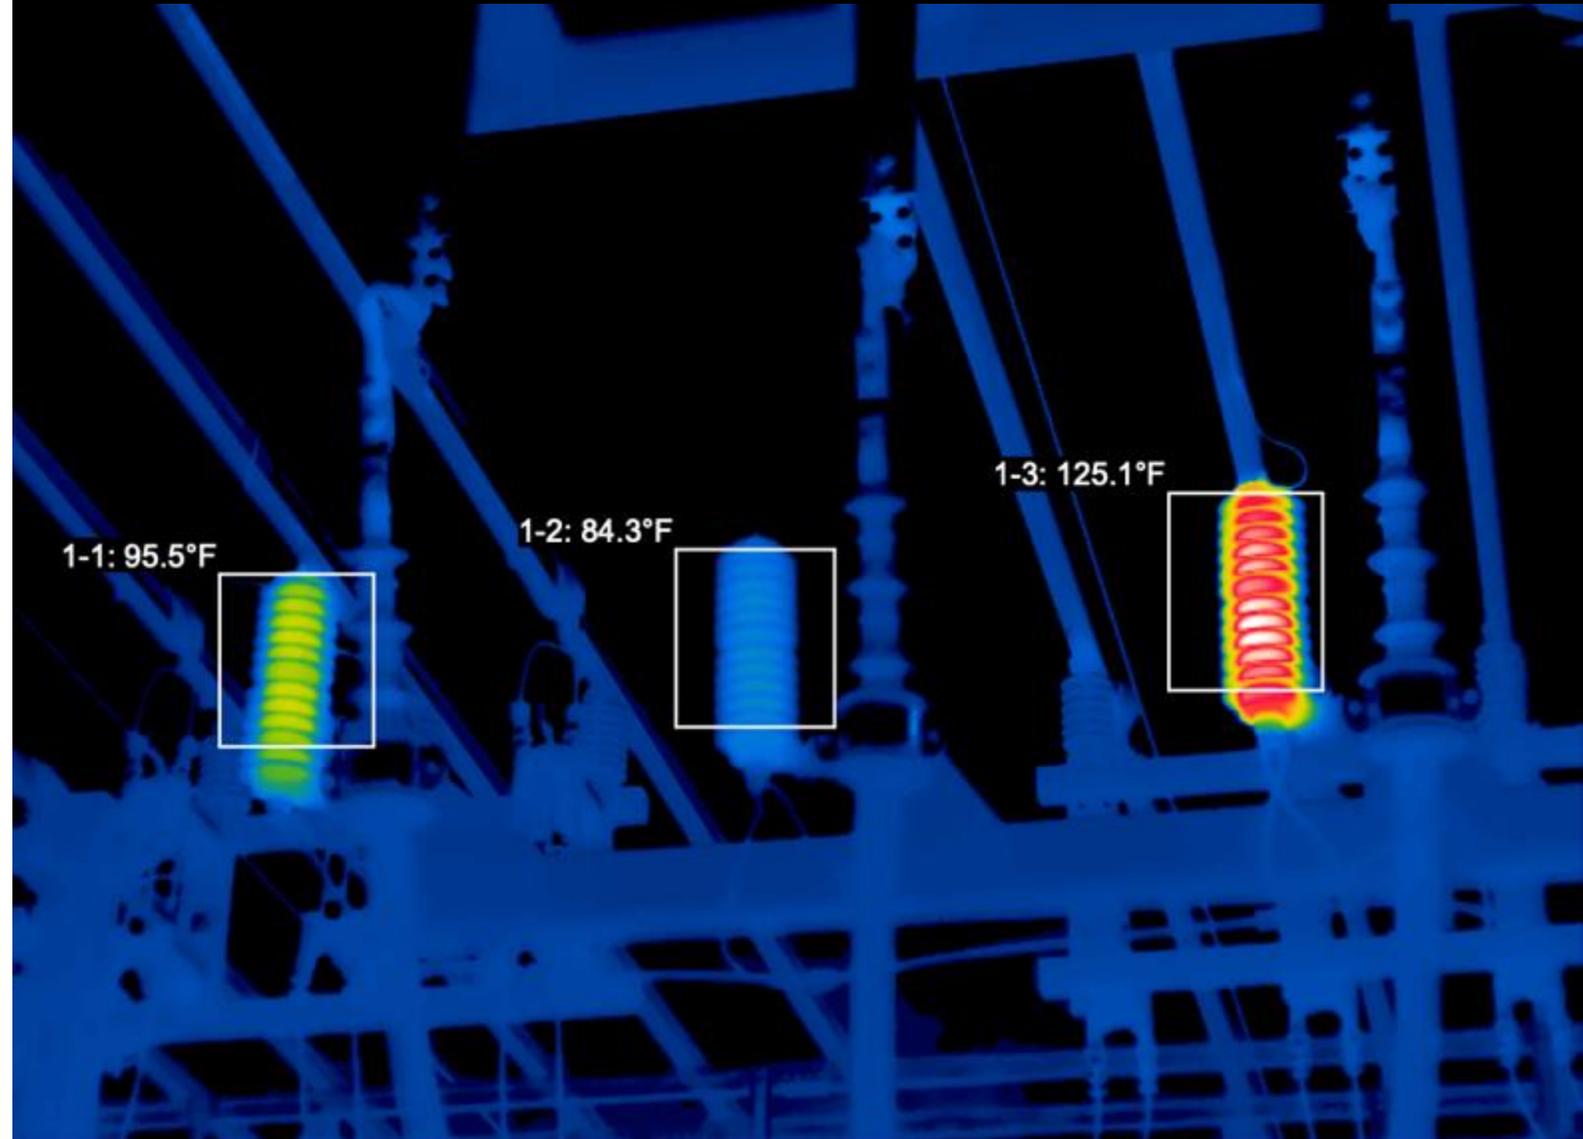
MAINTENANCE PRIORITY - THERMAL

- A hotspot is assessed as to how much hotter it is than other components of its type and its operating specifications.
 - Mainly qualitative differences in temperature are used for HV inspections.
- The maintenance priority is then assigned based on the likelihood of that component failing before a scheduled outage.

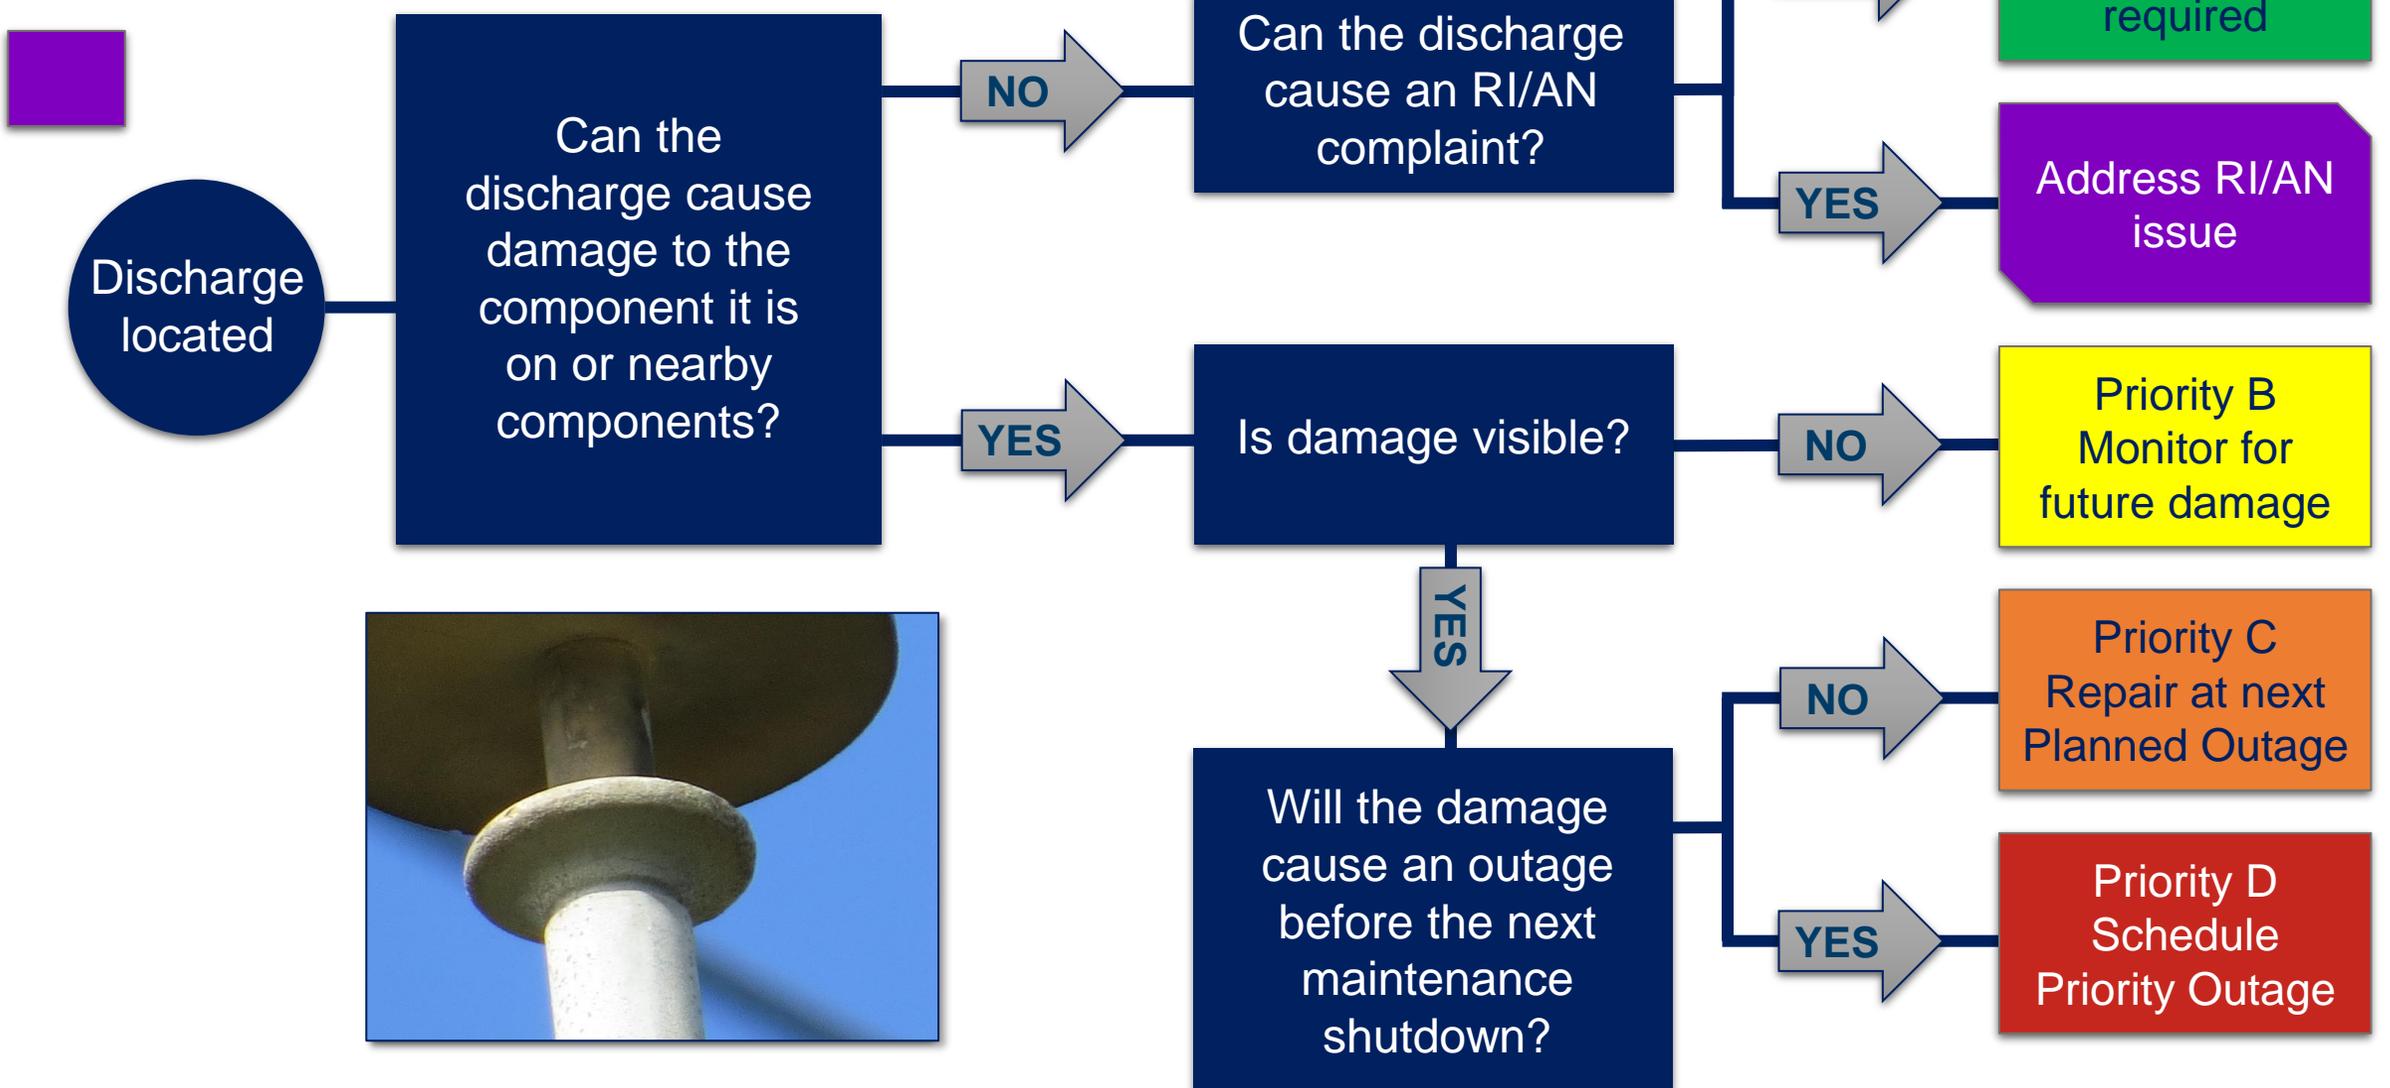
EPRI FIELD GUIDE - DECISION TREE

- The US EPRI® teaches a protocol to assign maintenance priority.
- Discharges are assessed based on the likelihood of them causing an outage in the short term or damage to hardware which will result in an outage in the long term.
- The inspector needs to know if a discharge at the discharge location can cause damage which would compromise the system.
- How far along the damage has progressed is determined by visual inspection of the discharge point and surrounding hardware.

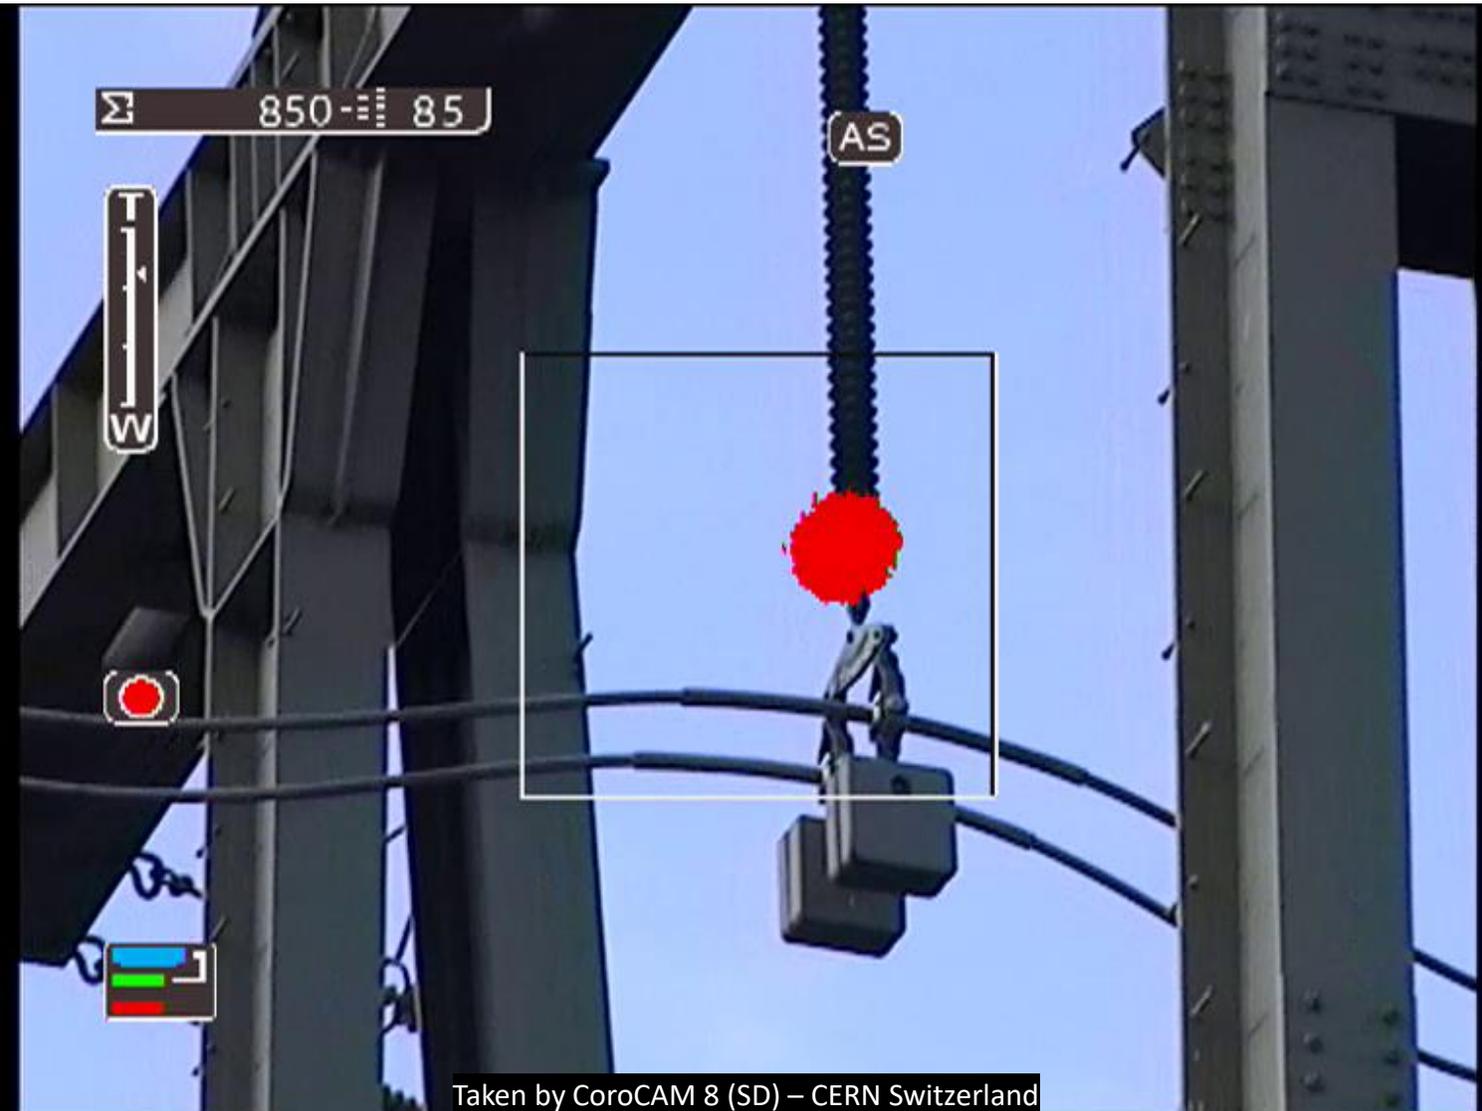
CORONA AND HOTSPOT CO-LOCATION

Consider this image, it shows a potential end fitting discharge, a visual close up of the insulator did not indicate any visual damage.

Since no visible damage is present yet, the failure would not be considered to be far along the 4-10 years timeframe from inception to failure due to an end fitting discharge.

Applying the US EPRI priority rating protocol would result in the following:

Priority B - Monitor for future damage.

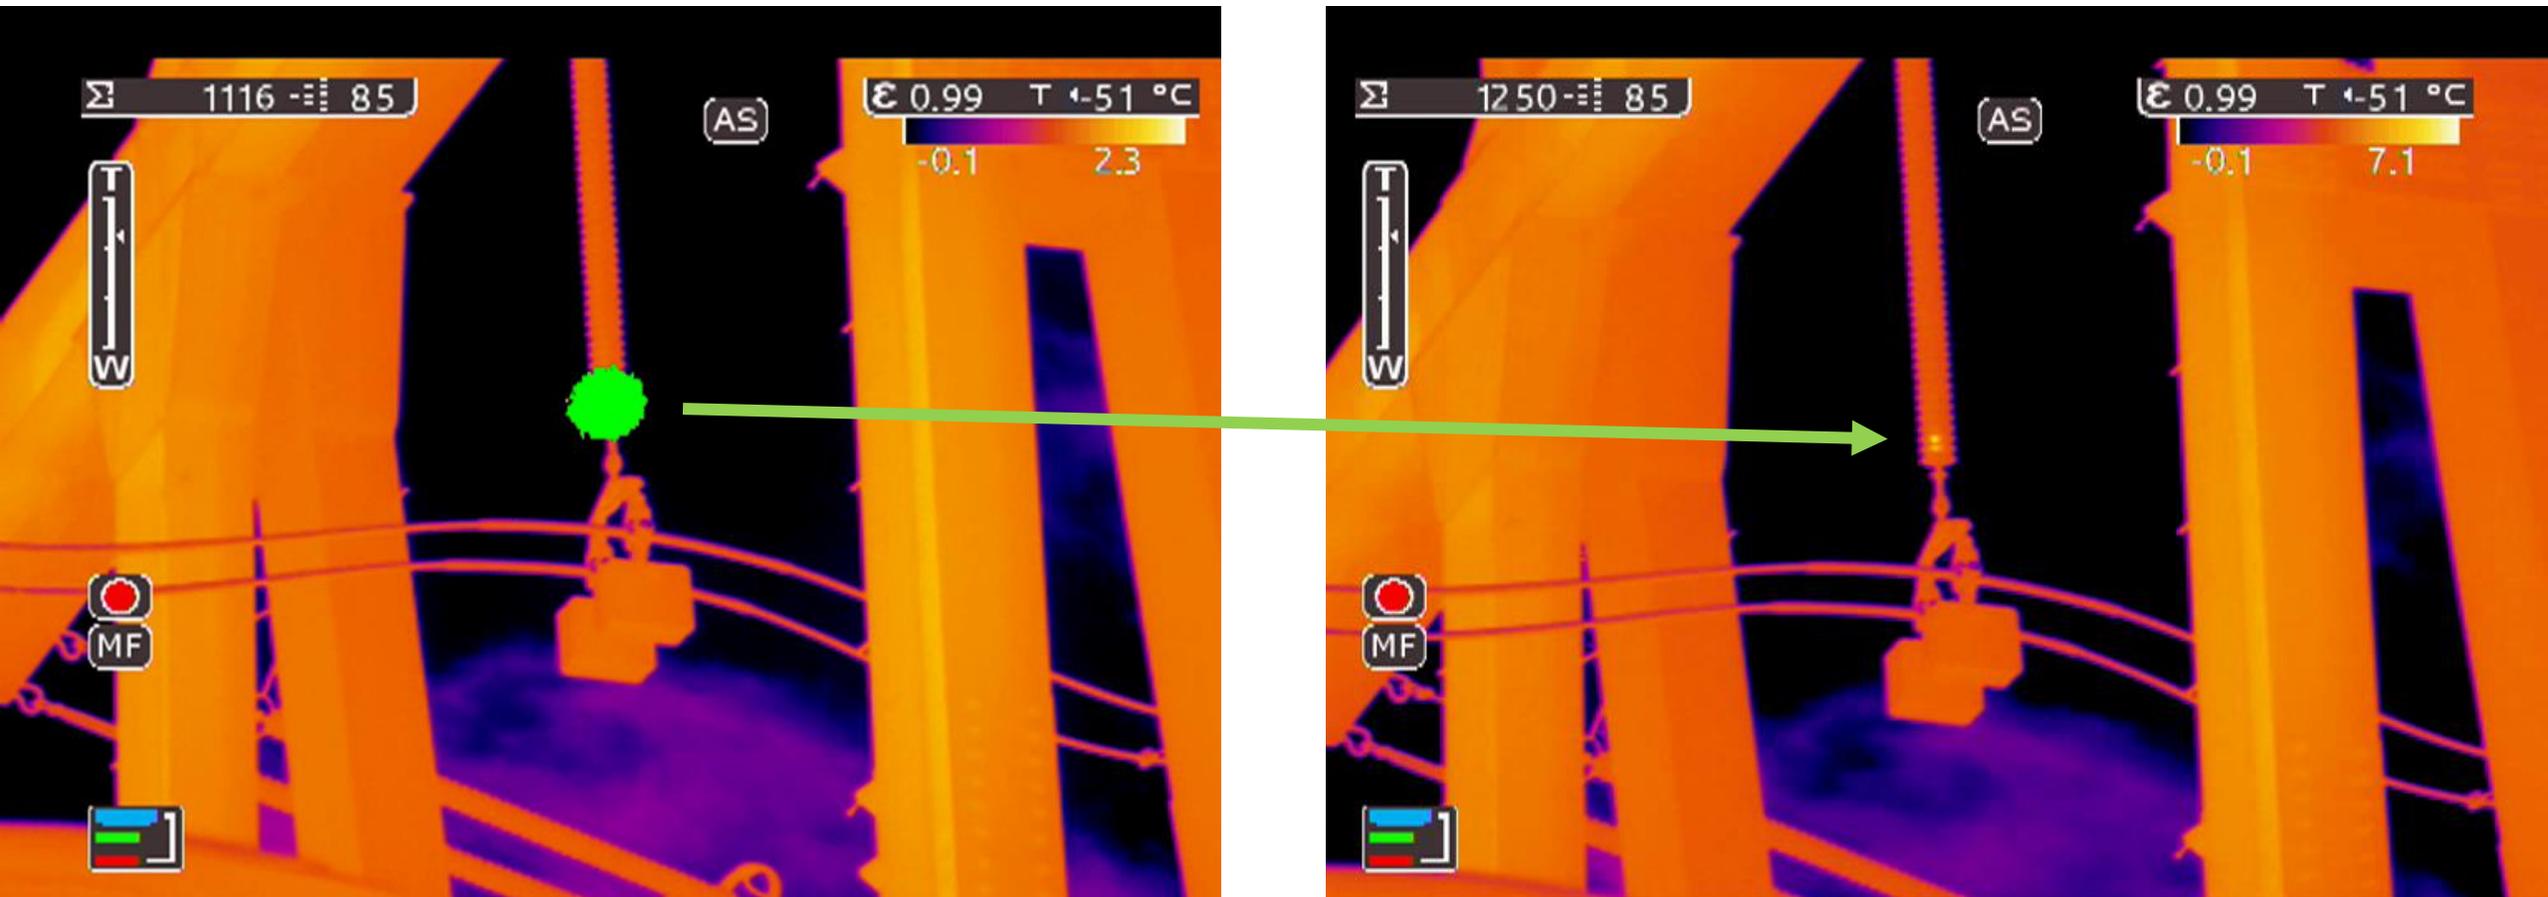
CORONA AND HOTSPOT CO-LOCATION

Removing the UV overlay shows the co-location of a hotspot, but not at the point identified.

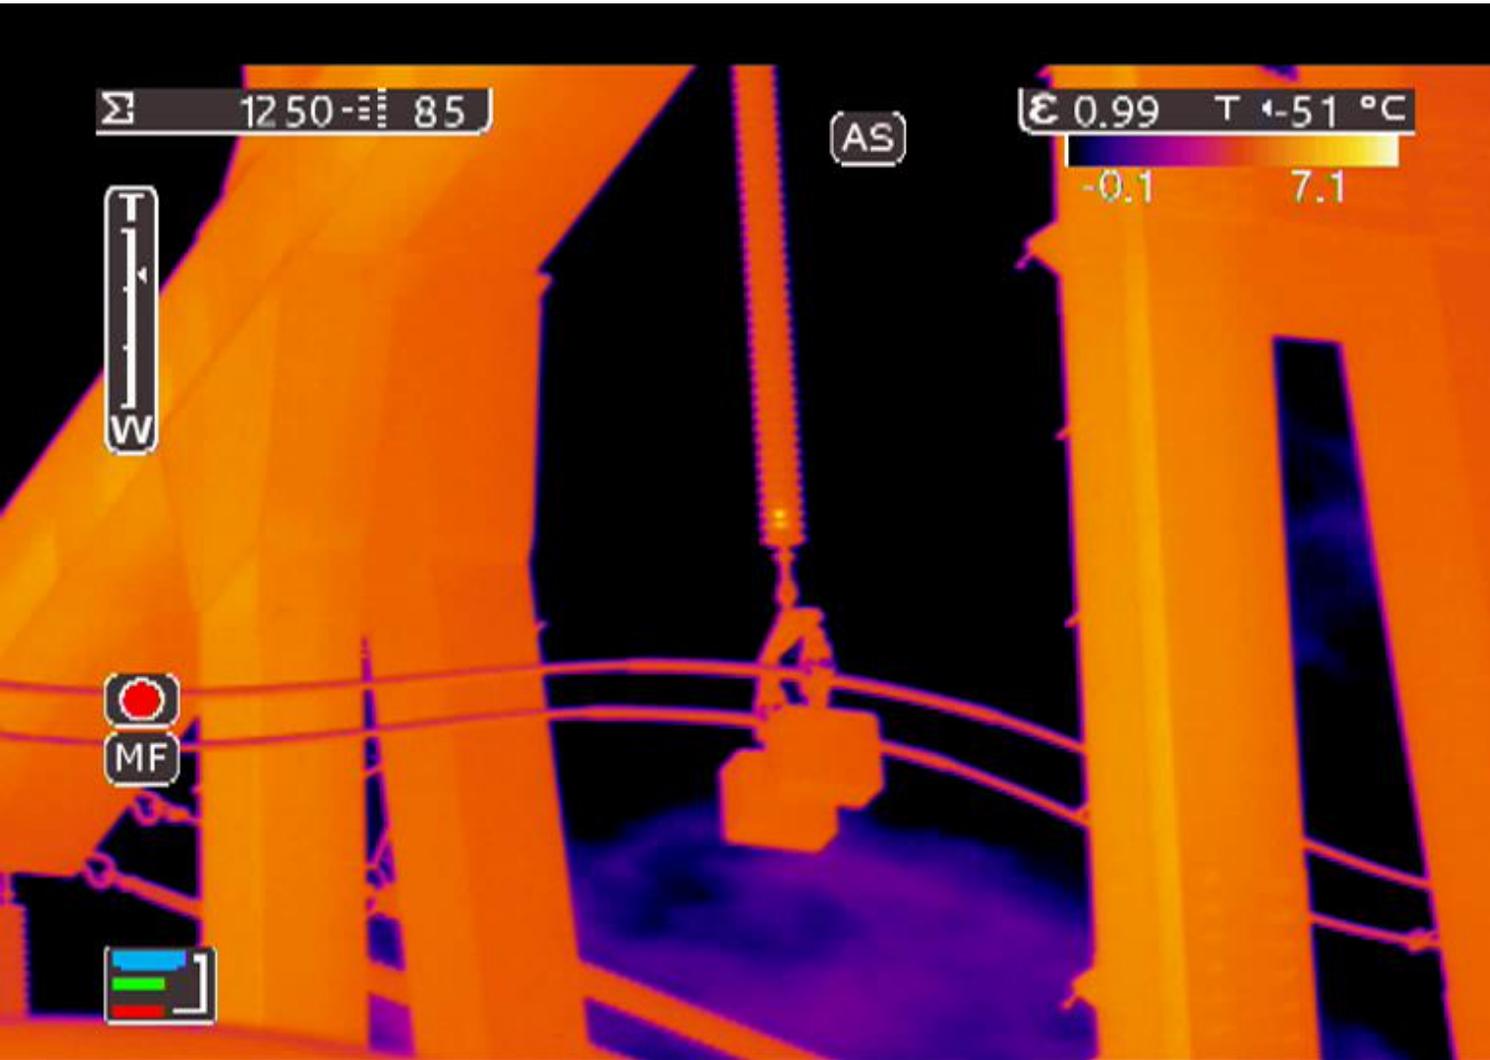
CORONA AND HOTSPOT CO-LOCATION

The hotspot is not at the end fitting, but further up the shaft, at the 2nd / 3rd shed.

This indicates that the discharge is actually from internal tracking.

Internal tracking can cause a failure anywhere between 0 to 2 years from inception, with no visual signature.

Therefore priority C or D should be applied.

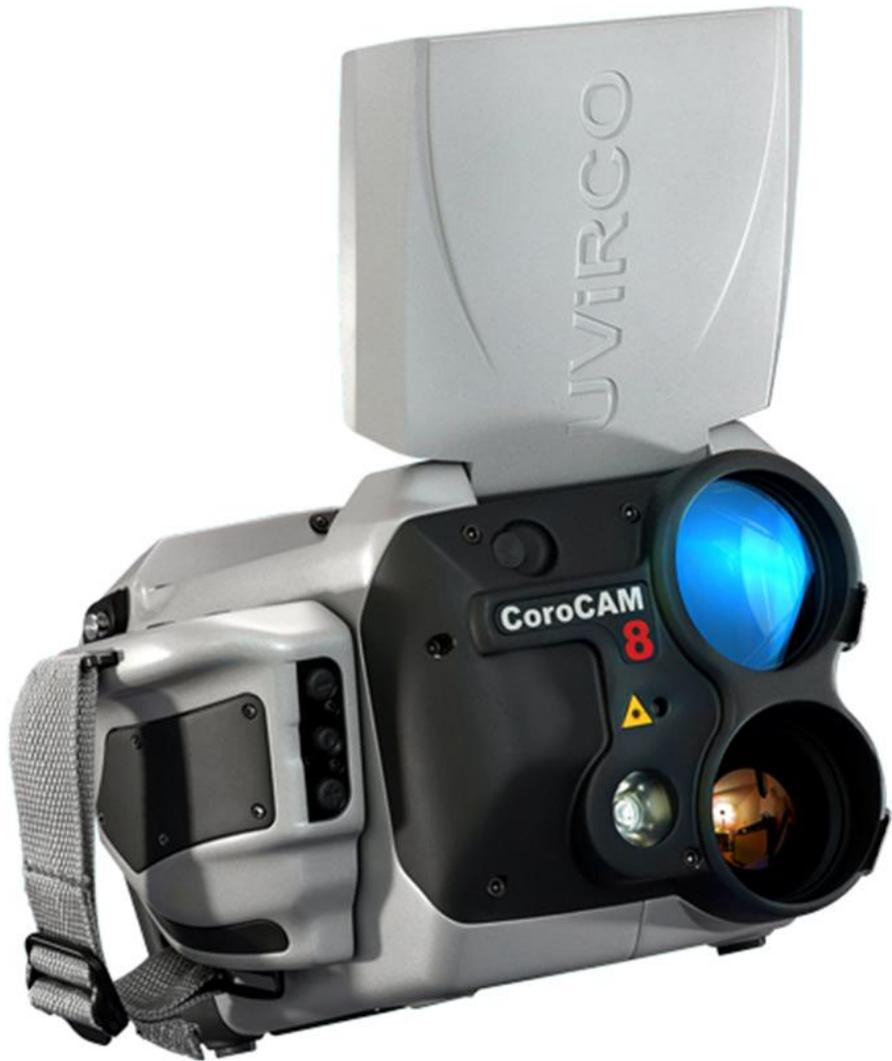
CORONA AND HOTSPOT CO-LOCATION

Using a UV/Visible only camera would not have successfully avoided the outage which could have resulted!
